Field Meeting Report: Building stones in the churches and church yards of the Stretton Hills, led by David Pannett and Andrew Jenkinson, 15th May 2004

ROSENBAUM, M.S. (2006). Field Meeting Report: Building stones in the churches and church yards of the Stretton Hills, led by David Pannett and Andrew Jenkinson, 15th May 2004. *Proceedings of the Shropshire Geological Society*, **11**, 5-11. The field excursion which met at Craven Arms on May 15th 2004 focused on the Stretton Hills. This area is well known for its complex geology and associated landscape patterns, reflected in the choice of building stones. Geology and local history have made each of the churches different, but they nevertheless reveal some common trends. Three of them (St Laurence Church Stretton, St James Cardington, and St Peter Rushbury) still have Norman naves built of locally derived rubble, later modified by better quality stone such as that from Grinshill. Meanwhile, the church of St Margaret at Acton Scott persevered in its use of the stone won from its own local and unique outcrop of Ordovician Acton Scott Limestone.

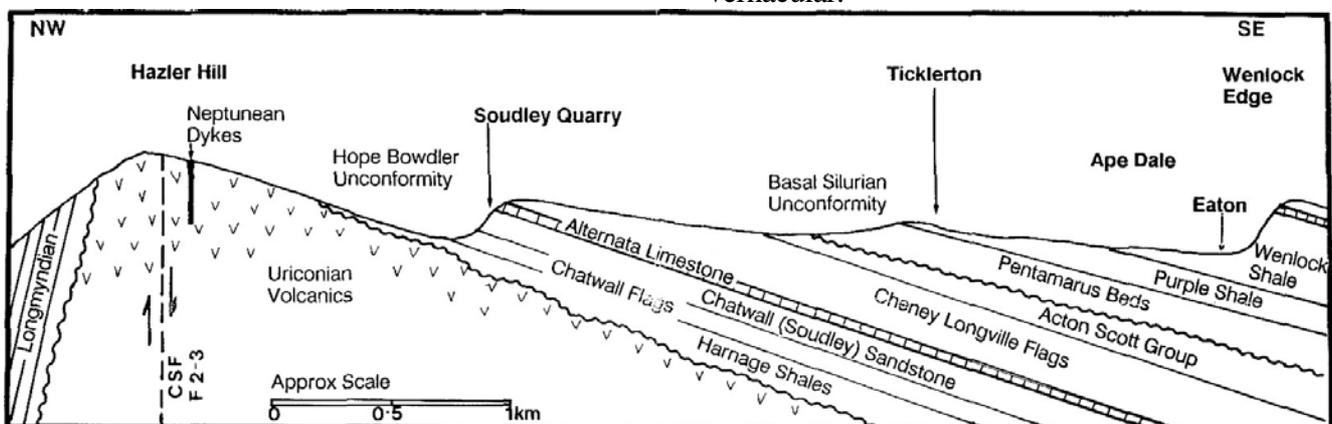
Figure 1. Geological cross-section E-W through the Stretton Hills.

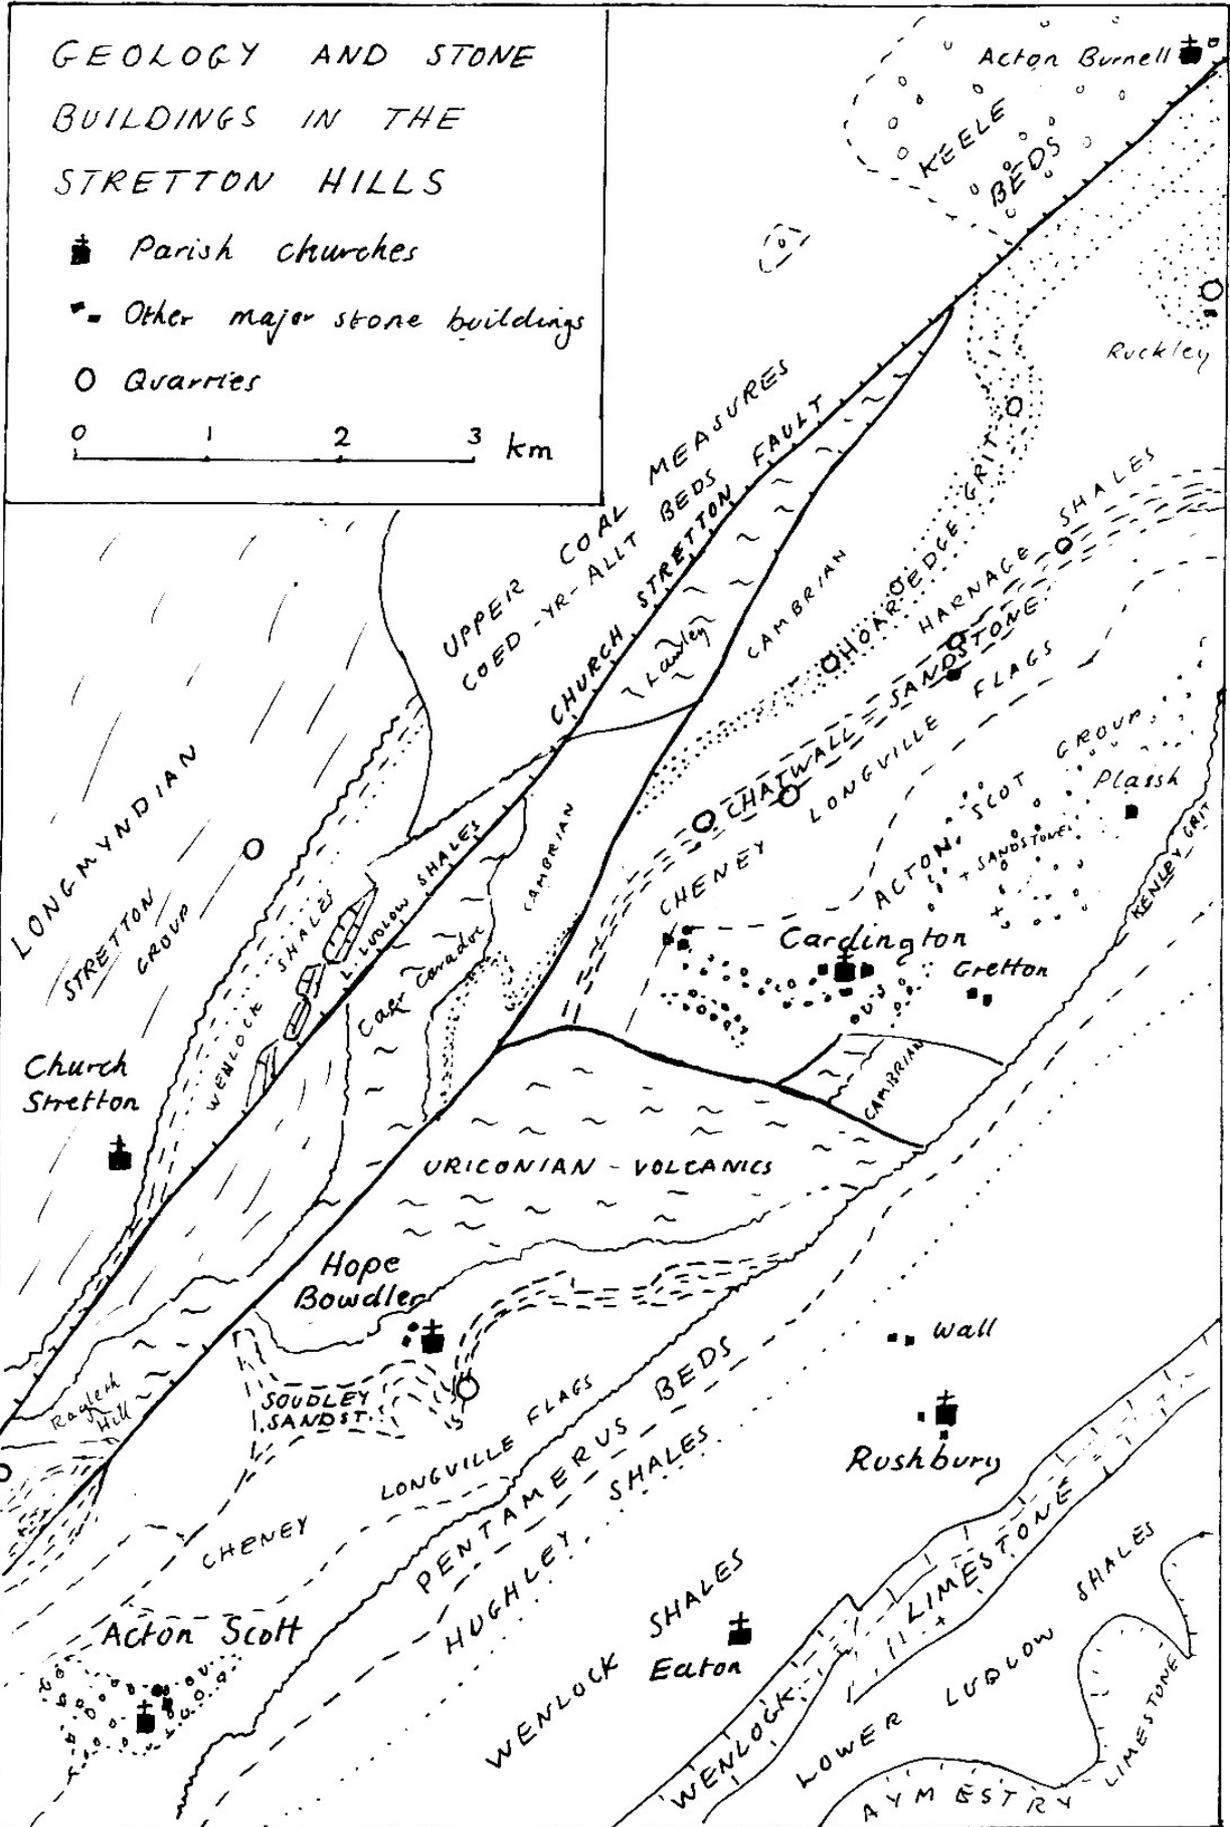
Figure 2. Geological sketch map of the Stretton Hills, showing locations of the churches mentioned in this paper.

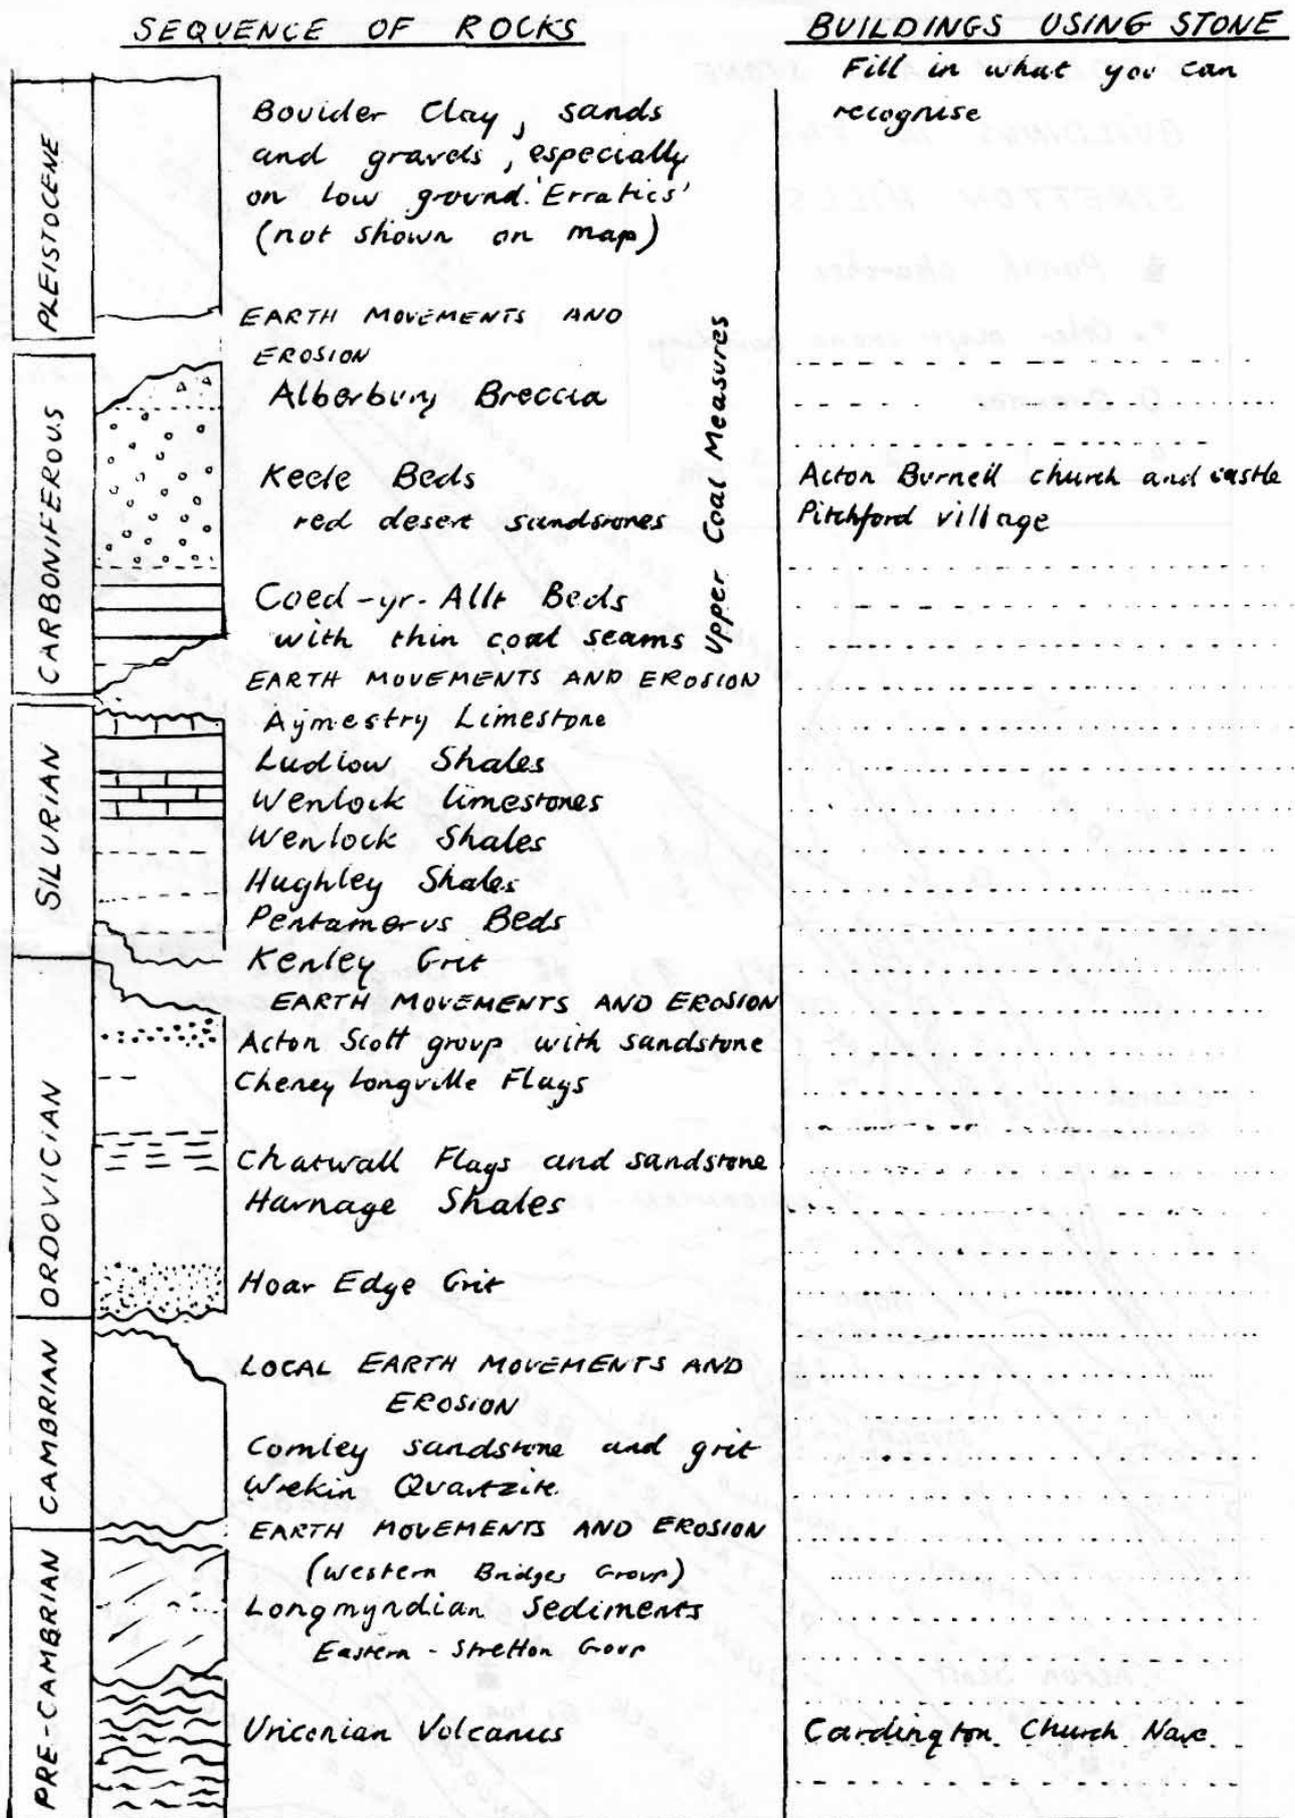
Figure 3. Pro forma for usage of building stone in churches within the Stretton Hills.

The field excursion led by David Pannett and Andrew Jenkinson, which met at Craven Arms on May 15th 2004, focused on churches around the Stretton Hills. This area is well known for its complex geology and associated landscape patterns, which might be expected to be reflected in the choice of building stones. The context of this field excursion is portrayed in the geological map and cross-section (Figures 1 and 2) and the more general aspects are considered in the accompanying paper by David Pannett (2006). Participants were invited to confirm their understanding of stone usage by compiling their own inventory using the *pro forma* supplied by the leaders (Figure 3).

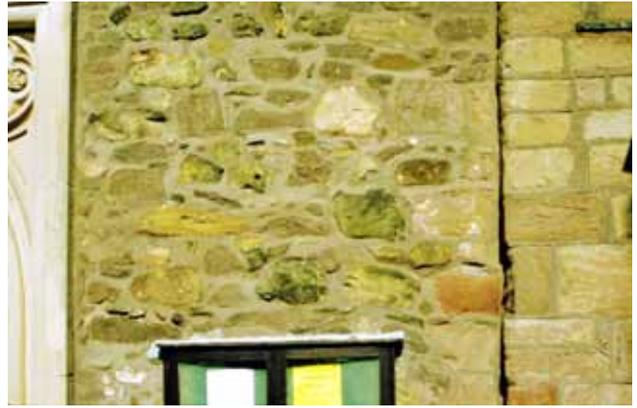
Figure 4. Mixed rubble stone. West front, St Laurence Church Stretton.

The first task set the participants was to identify as many different building stones as possible. The basic terminology was explained: rubble (rough stone) (Figure 4), coursed (layered), ashlar (shaped, with neat faces), jamb (margin of door), pilaster (corner) and quoin (edge).

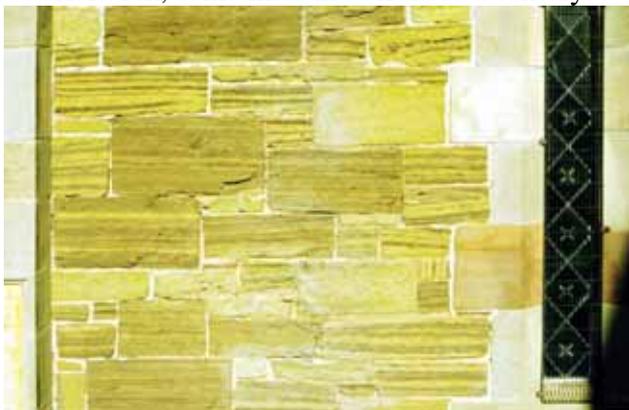
Figure 5. Soudley Sandstone. Northern transept, St Laurence Church Stretton.

The pale grey Grinshill Sandstone is of Triassic age, but the ashlar here is predominantly of Soudley Sandstone, a distinctive banded grey/green and dark red rock of Ordovician age worked for a long time at Soudley, and

The characteristic banding of the Soudley Sandstone caused much discussion. The shapes of the distinctive banded grey/green and dark red alternations were reminiscent of cross-bedding (Figure 5). The red colouration appeared to be due to oxidation of iron minerals within the sandstone, which might well be diagenetic or due to groundwater migration, or might relate to bacterial attack on organic matter within the original sediment. Close examination suggested that the initial colouration may have been yellowish brown. The red brown colouration is later and appears to be associated with calcite. The green colouration may be organic-rich or clay-rich, facilitating reduction of the iron minerals, or perhaps it is just due to calcite depletion.

Some ashlar blocks are distinctly cross-bedded, enabling “way-up” criteria to be applied. This led to discussion concerning the resistance of stone to weathering; generally stone placed with the same orientation as it has within the ground prior to quarrying exhibits the greatest resistance to weathering when placed as a building stone. Stone placed with its bedding or foliation on edge suffers from stress relief, cracking and allowing ingress of water. Frost, algal and plant growth subsequently fragments the stone and leads to its premature deterioration, sometimes in as little as a century.

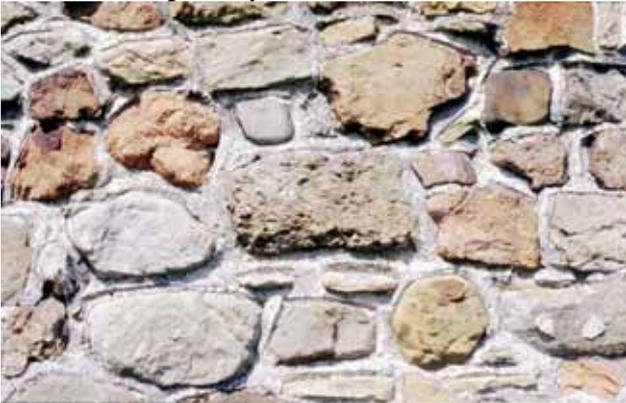
Figure 6. Geological mixture in Norman wall, Cardington Church.

The 13th Century building showed that whatever material was to hand was employed

(Figure 6); examples included: Uriconian volcanics, Cambrian Wrekin Quartzite, Ordovician Hoar Edge Grit (yellowish coarse grit stone) and Cheney Longville Flags (grey sandstone), Silurian *Pentamerus* Beds (shelly limestone), and various glacial erratics (mostly dolerite, but one piece of red granophyre was observed, probably Eskdale "Granite"). Jambs and quoins are predominantly made of Hoar Edge Grit (white sandstone). The 13th Century chancel to the west is more uniform, predominantly Hoar Edge Grit (Figure 7). However, restoration has employed Grinshill Sandstone, especially notable in the windows.

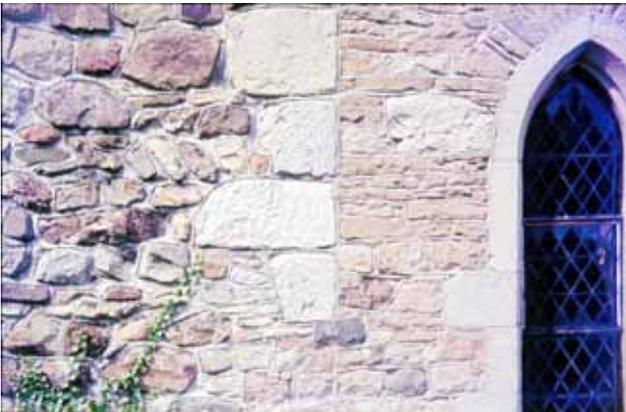
Figure 7. Predominantly Hoar Edge Grit. Norman nave left, 13th Century Chancel right; Cardington Church.

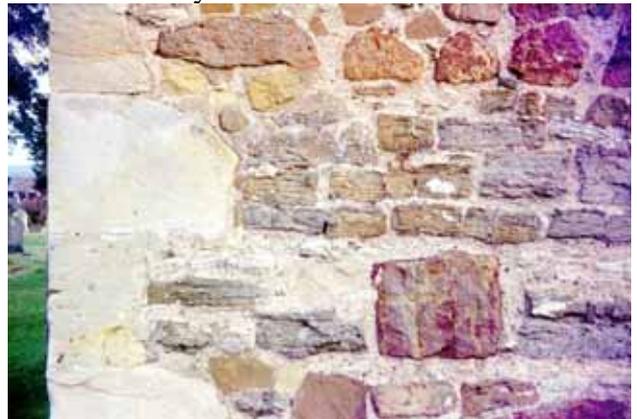
Figure 8. Rushbury Church, revealing Soudley Sandstone, Wenlock Limestone and possibly Hoar Edge Grit.

Examination of the west wall of the church tower revealed that the jambs and quoins were made of Chatwall Sandstone, not of the nearby Wenlock Limestone. This suggests that stone from

Other building stones include the basal Silurian Kenley Grit (coarse ferruginous sandstone with quartz pebbles), Hoar Edge Grit, a bedded limestone, and a silty shale. The latter is strongly laminated and reveals occasional sedimentary slumps; it is probably the local stone forming the ridge upon which the church and village are situated. The Kenley Grit has also been used for the 1860s vestry.

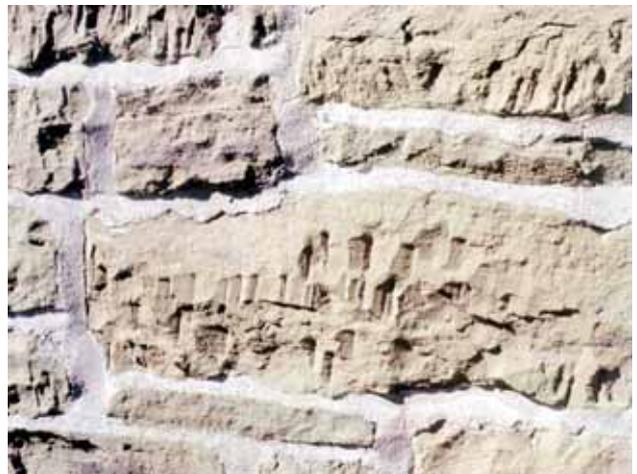
Figure 9. Rushbury Church, revealing Soudley Sandstone with 19th Century tool marks - 'rustication'.
